BALTIMORE CITY TRENCHLESS: HOWARD STREET WATER LEAK INVESTIGATION & REPAIR

By: Richard Thomasson, P.E., Khalid Qadwai, P.E., PMP, EBA Engineering Inc.

ACTIVE WATER LEAK ON HOWARD STREET

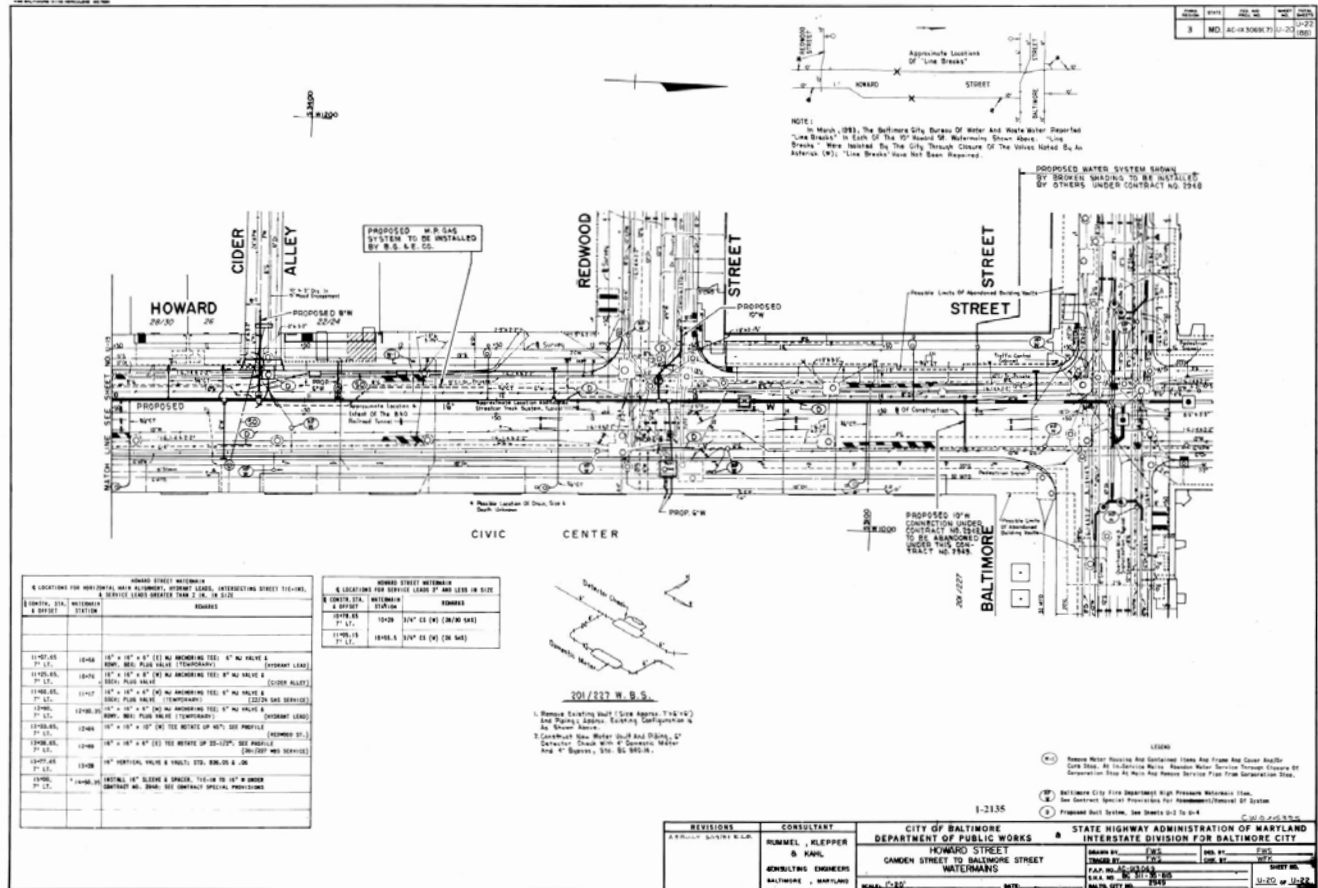
Figure 1: As-built plan view of leak area under Howard Street showing congestion of utilities

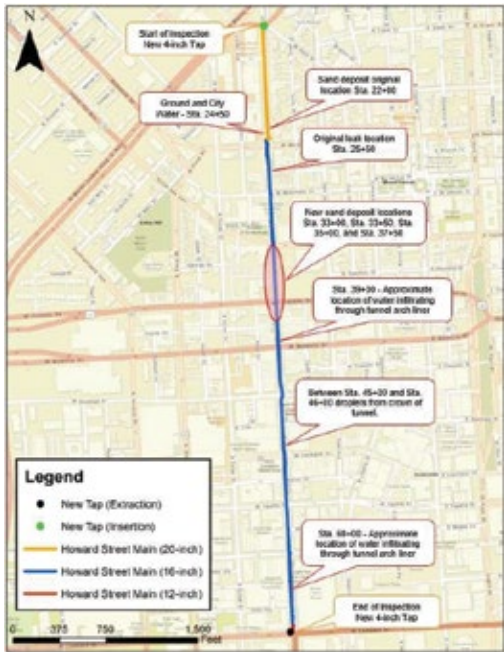
Figure 2: Plan of the SmartBall inspection

Pure Technologies completed the SmartBall inspection on Sunday, August 8, 2021. The SmartBall leak and gas pocket detection survey used acoustic technology to detect potential leaks and any areas of trapped or entrained gas within the pipeline. The inspection spanned approximately 4,969 feet (0.94 miles) of the Howard Street Mall.

The analysis of the inspection data identified no acoustic events characteristic of entrained or trapped gas and three acoustic events characteristics of a leak. Based on the magnitude of the acoustic signature, the size of the first leak was estimated to be in the range of 2 - 10 gallons per minute (GPM). The size of the second and third leaks were estimated to be less than 2 GPM and were suspected feature-related leaks. This estimate was determined by comparing decibel levels of detected leaks with calibration data collected during test trials and validations. Pure Technologies' analytic process used tracking sensor data, along with the tool's internal rotational and heading data, to identify the location of each leak.

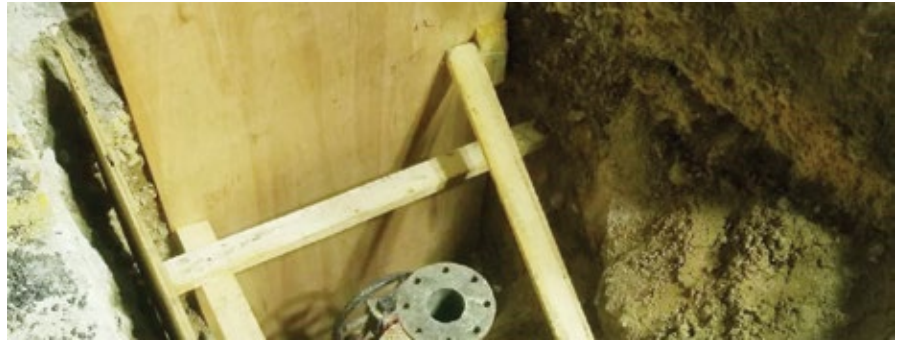
Figure 3: Installed entry port for the SmartBall was outside the special pad area of the light rail tracks

It was not an easy task to find a water leak with unknown origin. Several utilities are present along Howard St including water, sewer, storm, steam, cable, electric, telecommunication, etc. Several utilities and structures were CCTVed, finally Pure Technologies was retained and performed analysis of the watermain by use of the trenchless technology inspection application, the Smart Ball. The location of the three leaks were identified and marked above ground on Howard Street. Normal procedures for locating the leaks were not applicable because of the Light Rail special pad along Howard Street. The installed entry point for the tool was just outside of this special pad area of the light rail tracks.

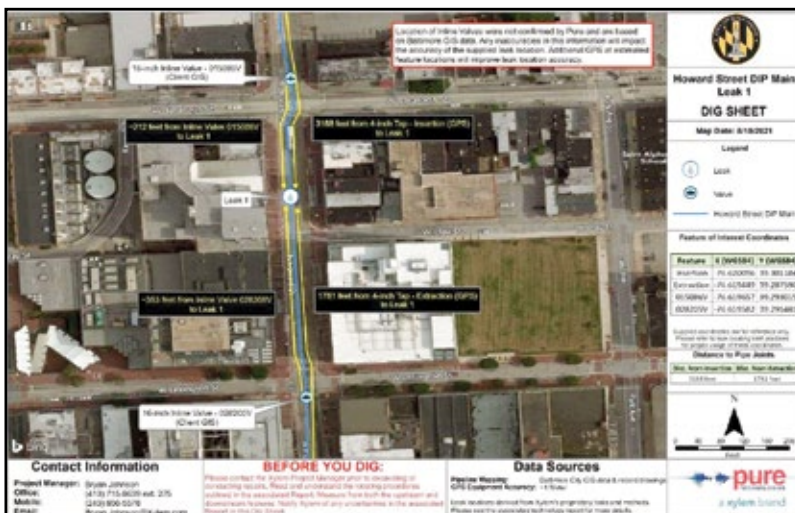
Figure 4: Dig Sheet showing location of Leak 1 under Howard Street

The first leak was located approximately 1,781 feet upstream from the 4-inch extraction tap at the intersection of Howard Street and West Lombard Street. Given the location and acoustic signature, Pure Technologies was uncertain whether the leak was located at the barrel or at the joint.

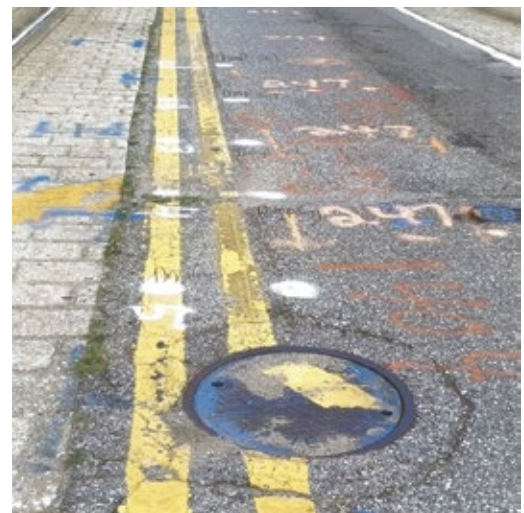
Figure 5: Dual use by vehicles and light rail was a complicating factor

location of the special pad for the Light Rail trains and the stipulation there was no cutting into the slab, which covered a good portion of the Howard Street width. Another complication was the dual use of Howard Street by vehicles and the Light Rail, with the tracks are on each side of the street and a travel lane in the center. The layout changed periodically through the 3 leak areas with a light rail stop in one area.

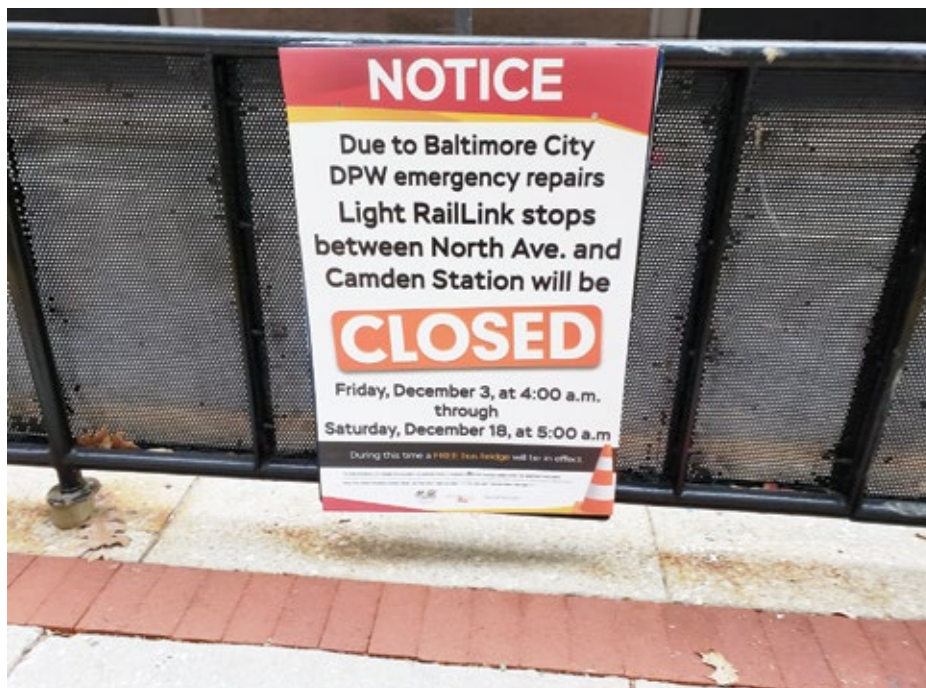
Figure 6: Light rail stops were closed during repairs

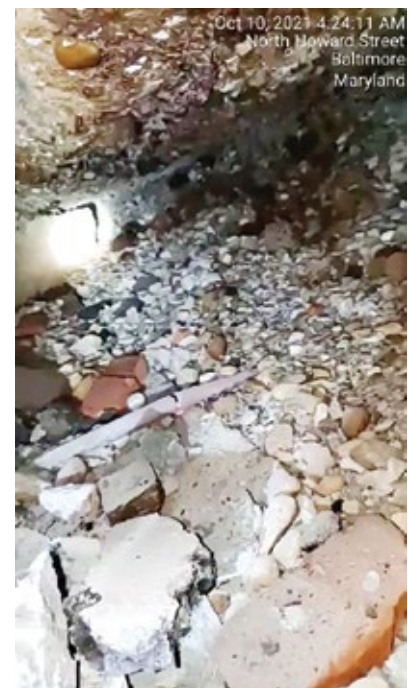
Figure 7: One of the largest voids discovered under the light rail slab

While the contractor was repairing the water house connection he discovered a large 16 x 22-foot sink hole that went all the way to the CSX tunnel. The leaking water from the house connection washed away all the soil into the CSX tunnel. MTA, Baltimore City DOT and CSX was immediately notified of the sink hole issue. Since the CSX tunnel inspection indicated there was silt entering with the leaking water, it was expected that there would be some voids under the light rail pad that would need to be filled. Train operation and

Controlled Low Strength Material (CLSM) was designed to fill the void and deliver at a rate so that it would not seep into the CSX tunnel underneath. Continuous monitoring of the CSX tunnel

Coordination with CSX, MTA and the City was necessary to determine a plan for the filling of the voids. Comments were received from each as to their requirements. The CSX tunnel was inspected and monitored while flowable fill was being installed to ensure no fill was coming into the tunnel. The mix was formulated to flow into the voids but thick enough to not infiltrate into the CSX tunnel.

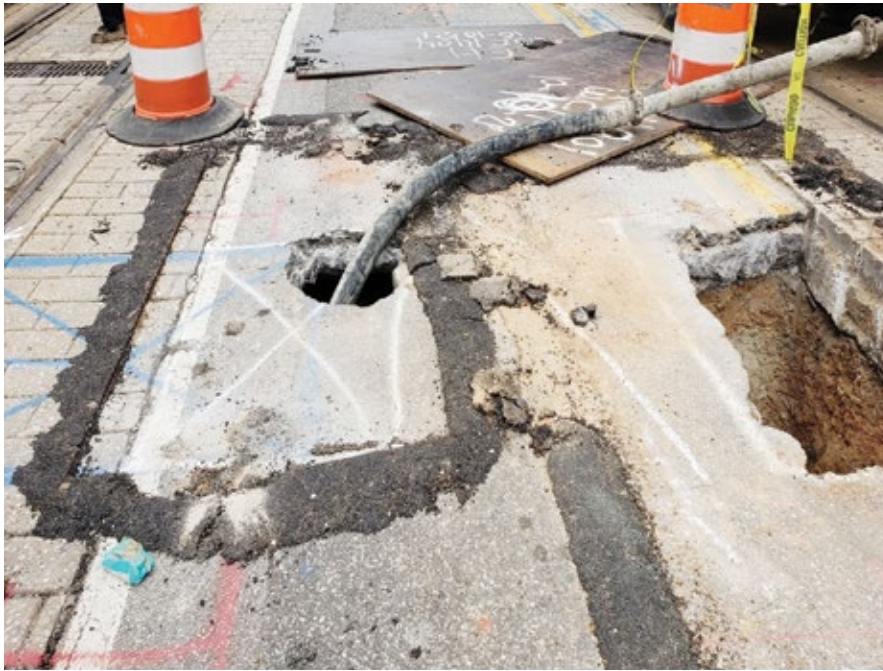
Figure 8: Grouting of major void with flowable fill, with access just outside of light rail slab

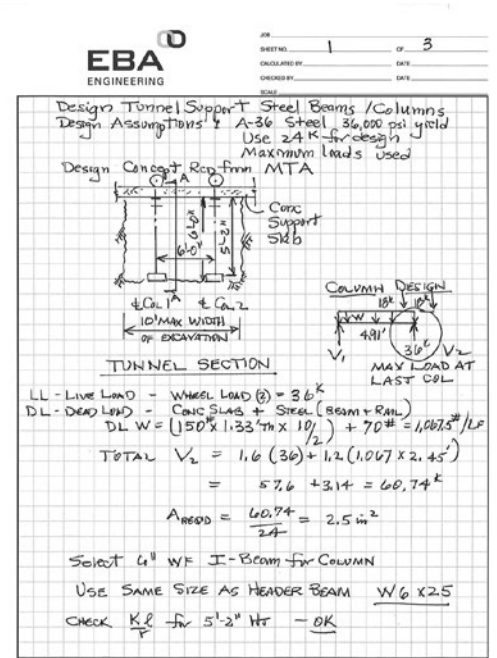
Figure 10: Sketch of tunnel design showing detail and calculations

The normal method of replacing the packing could not be used because no excavation could take place on the special light rail slab. Therefore, the Contractor was required to build a tunnel from outside the light rail slab area to the valve in order to complete the repair. EBA designed the tunnel and submitted for approval by the MTA and CSX. It was a very challenging design as the tunnel was designed under the MTA light rail and over the CSX tunnel, with several crossing utilities. Trenchless options were considered but none worked out due to site condition.

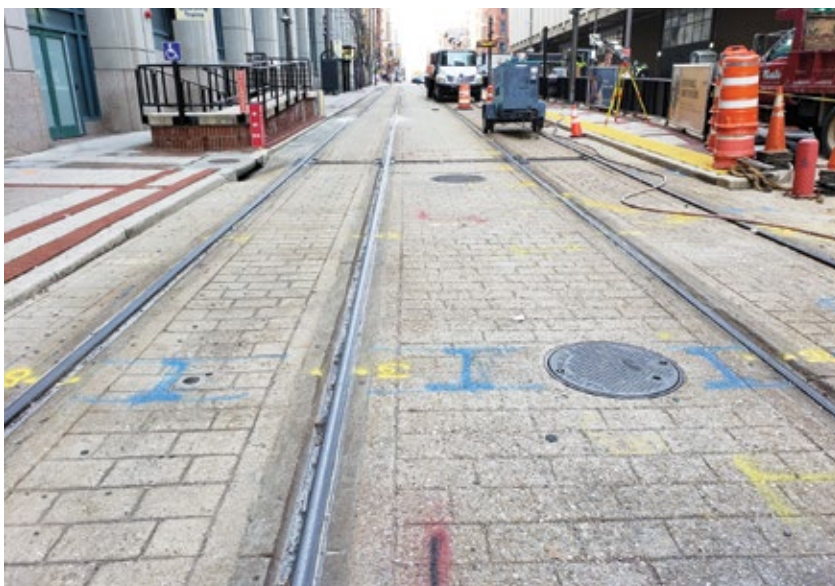
Figure 9: Location of leaking 8-inch valve. A tunnel was constructed to complete the repair

The second leak was valve packing on an 8-inch valve on the 8-inch water service located at 10 S Howard Street between the North and South bound Light Rail tracks.

The plan was developed to construct an 8 x 24-foot tunnel to access the valve under the Light Rail tracks and replace the packing to stop the leak.

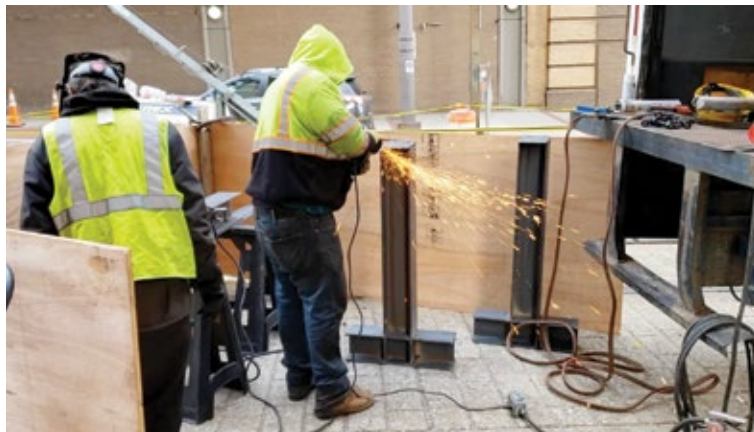
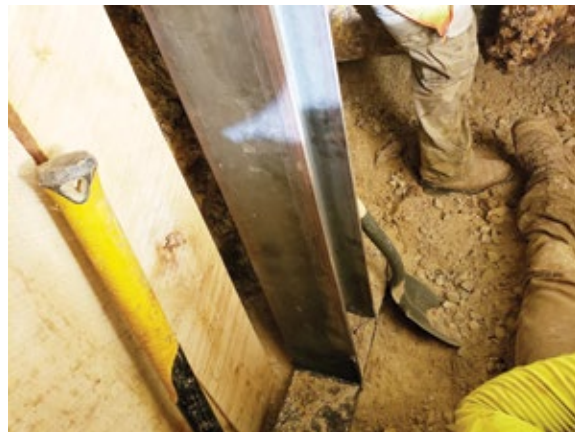
Figure 11: Construction of the steel tunnel system

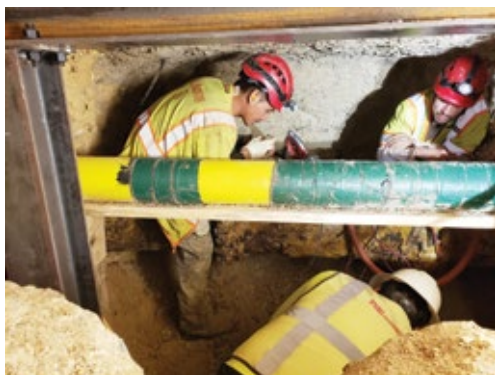
When tunneling toward the valve the shoring used to install CSX tunnel was encountered. EBA immediately coordinated a site meeting with the CSX and briefed them about the problem and possible solutions. CSX allowed the contractor to remove the shoring up to the wood lagging.

This complicated the tunneling operation and caused additional delay in the repair of the 8-inch valve.

Figure 12: When tunneling towards the valve, a large gas line was encountered
